COMPARISON OF RESTORATION TECHNIQUES FOR PUBLIC HERITAGE BUILDINGS

VeermataJijabai Technological Institute is 7th oldest institutes of education in India. VJTI was founded in 1887. It is more than 100 years old structure.VJTI is a historical monument (declared as heritage site by Govt. of Maharashtra) and even its hostels as well. (ref: archaeological Survey of India and Gazette of Bombay). VJTI building included in Heritage Grade 3 type buildings.

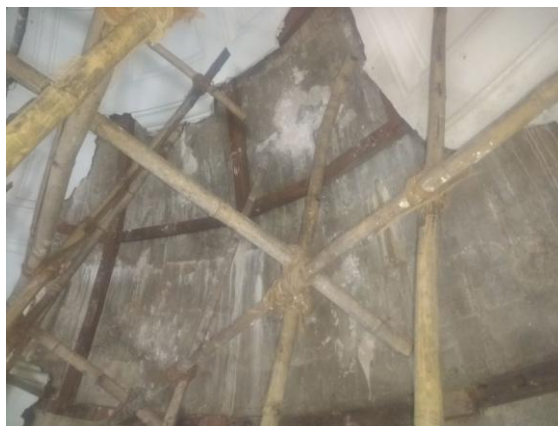
Figure 2:POP sheets and battens removal

Inner surface of dome was having plaster of paris sheets rested on wooden battens. Teak wood battens were fixed by long screw nailed in the dome concrete surface. Wooden battens were arranged on the periphery of inner surface of dome. Due to water leakages wooden batten were subjected to fungal growth and plaster of paris sheets rested on them were also starts deteriorated. Again by tamping method is used for checking. The sheets were not in good condition. Hence POP sheets and battens were removed. Some of the were so tightly fixed that they were removed by cutting. The holes of screws were also poured with cement mortar.

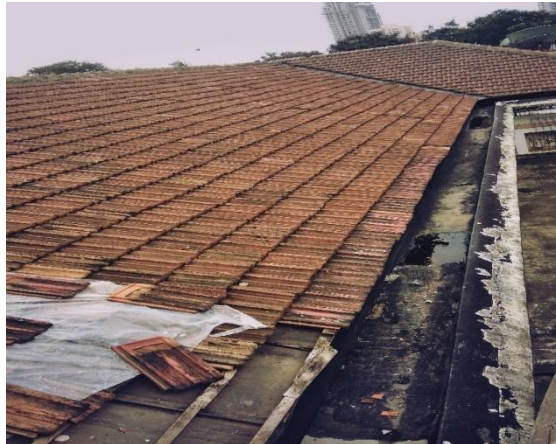
Figure 3:Roof Repairs

The roof was also having leakages. Some of the battens were subjected to white ants and fungal infection. Old tarfelt was torn on some places. For the roof repair work manglore tiles were and battens were removed. Water based bituminous coating like supreme bituchen was provided. The top marine plywood of 12 mm thickness is provided. Above that self adhesive water proofing membrane is provided. Battens of teak wood(50mm x 25mm)are used to rest the manglore tiles on them. As all battens were not subjected to termites or fungal attack so reused. Timber which is to be reused have to be tested. Moisture content tests and load bearing tests are taken. Manglore tiles are cleaned as much as possible. Fungal growth on them is removed with brushes. Chemical treatment of tiles i.e. anti algaeanti fungal treatment is done.

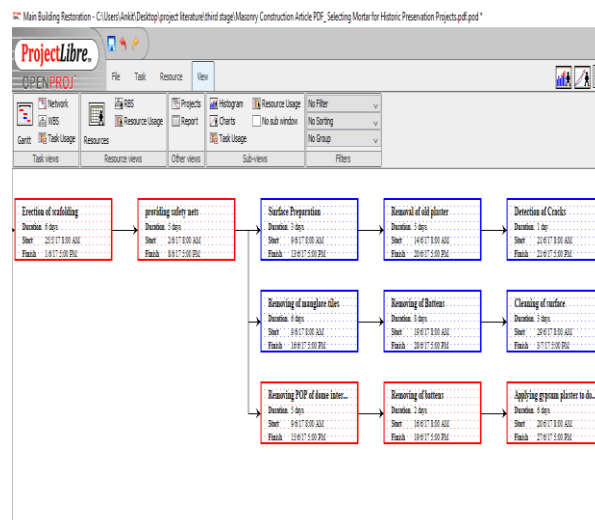
Figure 6:-Network diagram of WBS

All the activities their time duration with the requirement of sequence is the input for software.

The work breakdown structure so form by the software are compared on the basis of time. Ideally the work of repairs and restoration should require time of 5 months . the project started on 18th May, 2017 and the end date was 6th October,2017.

But the actual duration of the project was 7 months The project actually completed 29th December, 2017.
Note:-labour worked for 8 hours a day and work for 5 days in week is considered.
