# GLOBAL JOURNAL OF ENGINEERING SCIENCE AND RESEARCHES

## PREPARATION OF PATCHED SPECIMEN USING COMPOSITE MATERIAL TO RESTORE NATURAL FREQUENCIES OF EDGE CRACKED ALUMINUM CANTILEVER BEAM

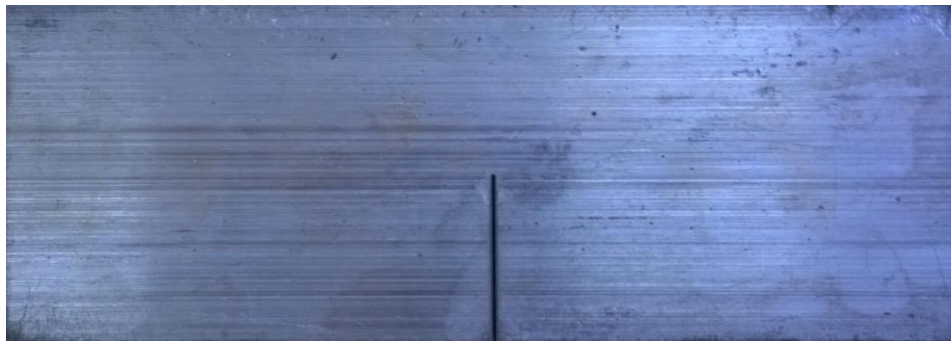
*Figure 2: Un-cracked specimen*

To prepare the edge crack, initially a cut of length of about 33 mm was made through a EDM as shown in figure 7. The width of the crack was about 1.25 mm. Then the crack was extended using a surgeon blade by about 1.5 mm length as shown in figure 8. To make the crack tip very sharp, a fresh razor blade was used to have the final crack extension by about 0.5 mm again by using a suitable designed blade holder. It is worth noting that the crack was made of thin width, only 2 mm because this kind of crack geometry is closer to cracks in most of the real life structures.
