GLOBAL JOURNAL OF ENGINEERING SCIENCE AND RESEARCHES SEISMIC ANALYSIS AND DESIGN OF STEP UP BUILDING USING STAAD PRO Syed Shaheen Sultan^{*1} & T.Ashok Reddy²

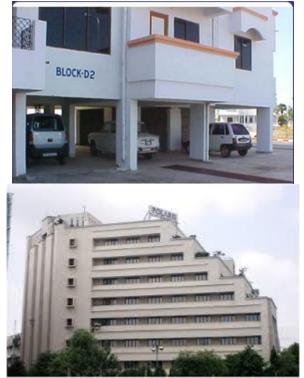
Figure 1&2 Irregular buildings

This type of irregularities arises due to unexpected decline of stiffness or strength in a particular storey. For high seismic zone area, irregularity in building is perhaps a great challenge to a good structural engineer. A large number of vertical irregular structures exist in present urban infrastructures. Among them Open ground storey as well as stepped types of buildings are very general in Urban India. A typical Open Ground Storey and a Stepped irregular framed building are shown in Figure.
